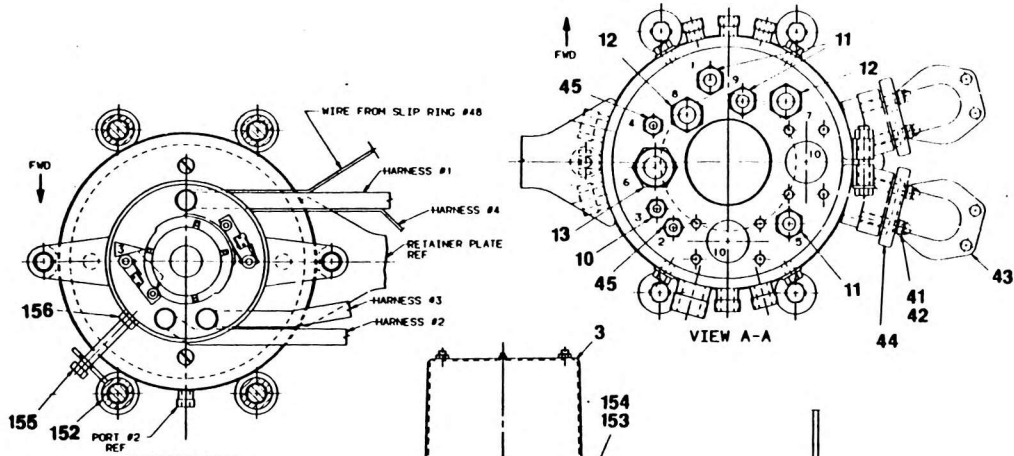
NOTE: SECTION NOT SHOWN IN TRUE VIEW. RETAINER PLATE HAS BEEN ROTATED 180° TO SHOW ITS PROPER POSITION WHEN MAKING CAN-SWITCH ADJUSTMENT (SEE NOTE 3)
